# SoLID HGC Prototype Vessel Leak Testing

University of Regina

June 21, 2021

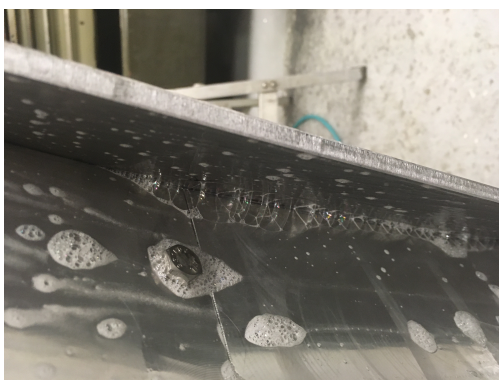
Figure 7: This is what a leak looks like when doing the soapy water test.

On February 8th, the front window with an O-ring was bolted to the vessel. The window's frame was accidentally placed on backwards, so it had to be taken and placed back on again. The vessel had no sealant or epoxy on it at this time. The vessel was pressurized with an air hose, but there were many leaks, enough that no differential pressure could be built up. Soapy water was sprayed onto the vessel to check for leaks (see Fig. 6). If a leak was found, it would bubble like in Fig. 7. Some of the leaks were large enough to feel by hand and to hear. They were located:

- edge of front plate towards the outer radius
- edges of side plate-left, especially where it connects to the back plate extension and the top plate
- between back Window and side plate
- between back window and rib
- a bad leak on the entire seam between the back plate and top plate
- between the top plates
- between front top and top plate

- some leaking on the bottom plates
- in the corner where the top plate, back plate and rib meets

Between February 9th–11th, the vessel was cleaned four times to prepare it for the sealant. Ethanol was used to clean most of the vessel and acetone was used to clean difficult areas. Rags were used to clean large areas, kimwipes where used to clean smaller areas and Q-tips where used to clean the seams. The first time, it was cleaned with ethanol using kimwipes. The second time, it was cleaned with ethanol using rags, kimwipes and Q-tips. The third and fourth times, it was cleaned with both ethanol and acetone separately, using rags, kimwipes and Q-tips. The cleaning was done with the vessel back panels removed, to allow for more ventilation, and a fan was used to help with air flow. Due to concerns with fumes while cleaning the vessel, breaks were given at least every hour. Foam was used for padding to protect knees. The setup can be seen in Fig. 8. The sealant was then applied on the 11th and the 12th. The setup was similar to the cleaning setup. A lamp was used to help illuminate the vessel and its heat helped the sealant to cure. Headlamps and flashlights were also used to illuminate the inside of the vessel.

About 7 tubes of RTV sealant were used. There were some challenges when applying the sealant. The sealant formed a skin rather quickly, roughly within five minutes, which made making a continuous seal difficult. If the sealant was applied too thickly, there was a tendency for air bubbles to form in the sealant. The glossy black finish made of the RTV it difficult to see imperfections in the application. On February 16th, the back panels were placed back on the vessel. RTV sealant was sandwiched between the back panels and the vessel (see Figs. 9 and 10). The panels were bolted on with 120 in-lbs of torque, as measured by a torque wrench, and the excess sealant on the inside of the vessel was smoothed down with a wet glove.

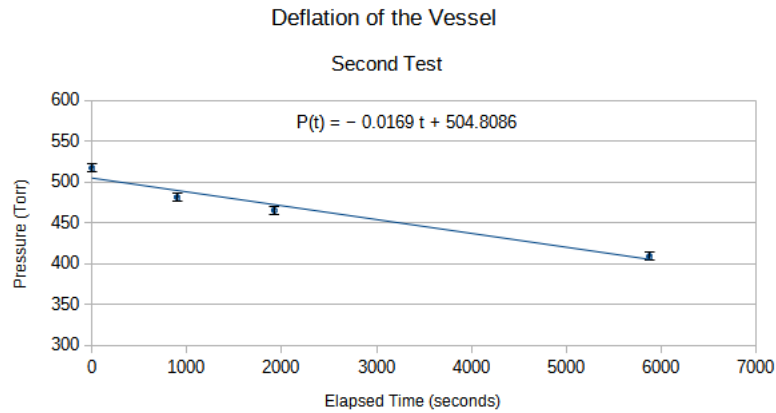
On February 19th, after the tank was cleaned and sealant was applied, the tank was tested for leaks. The vessel was inflated to 9.0 psi (relative pressure) and the inflation took roughly 8 minutes. The changes in pressure are listed in Table 3. A graph of the pressure over time is in Fig. 11, this graph was used to calculate the leak rate. The leak rate was  $19 \pm 1 \frac{\text{Torr-L}}{\text{s}}$ .

Figure 11: Result of Test 2. The leak rate of the vessel can be determined from the slope of this graph.

The vessel was checked for leaks using soapy water. The leaks were found:

- the outer radius and inner radius of the vessel
- around the gauge

Most of the leaks were on the top and bottom of the vessel. The front window was deflected when the vessel was inflated to 9.0 psi. The deflection was measured to be 2.125 inches.

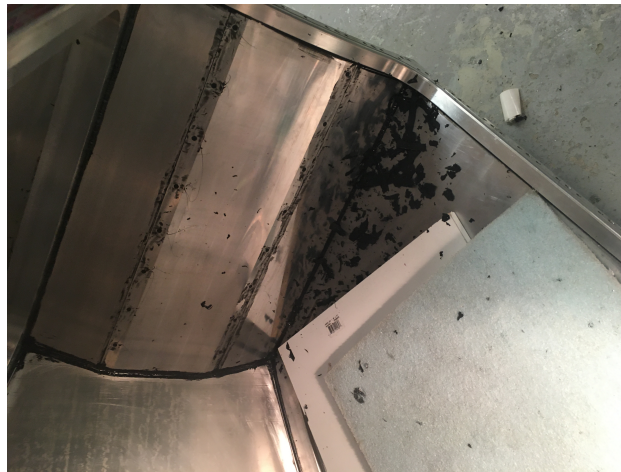
Figure 12: The sealant was scraped off with a utility knife.

After the vessel test on February 19th, we decided to scrape off sealant on areas that were most likely causing problems (see Fig. 12). These areas included the joints on the bottom of the vessel, as well as the top of the vessel. The sealant was scraped off with a utility blade and dissolved with ethanol and acetone. Ethanol tended to work better at dissolving the sealant. **Scratches were added to the aluminum near the seams so that the sealant will adhere better. On February 23rd, the sealant was applied to the scraped off areas. The bottom seams were sanded and cleaned. Several holes on the inside radius penetrated through into the vessel. To seal the two rows of holes, thin wood spacers (0.090 inches thick) were stuck to either side of them with double-sided tape (see Fig. 13). The wood spacers were used as screeds to allow a thicker layer of sealant over the holes, they were removed after the sealant cured. This thicker layer of sealant covered up the seams better than before (see Fig.14).**

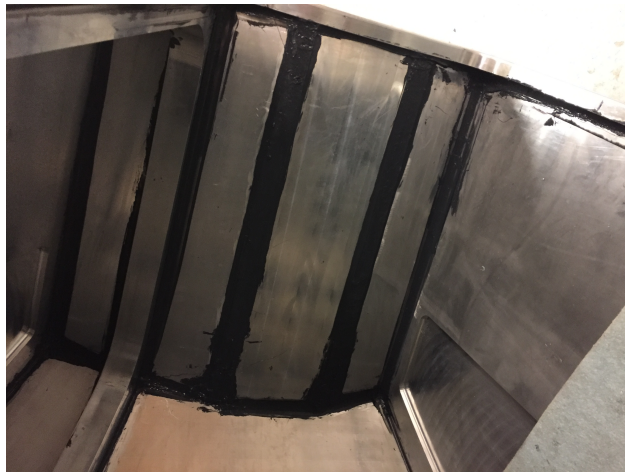
Figure 13: The bottom panel's seam were covered in a thick layer of sealant.

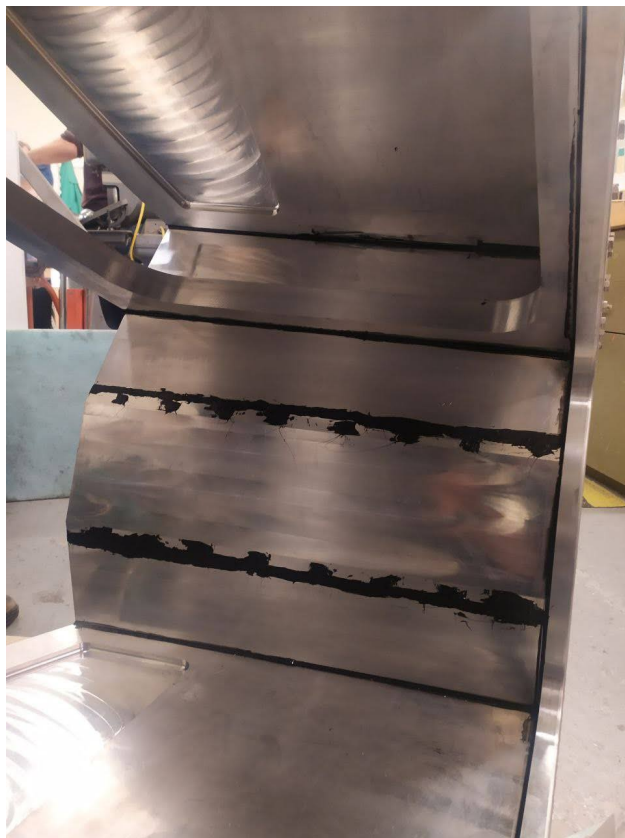
Figure 14: The sealant on the bottom panels before scraping, for comparison.

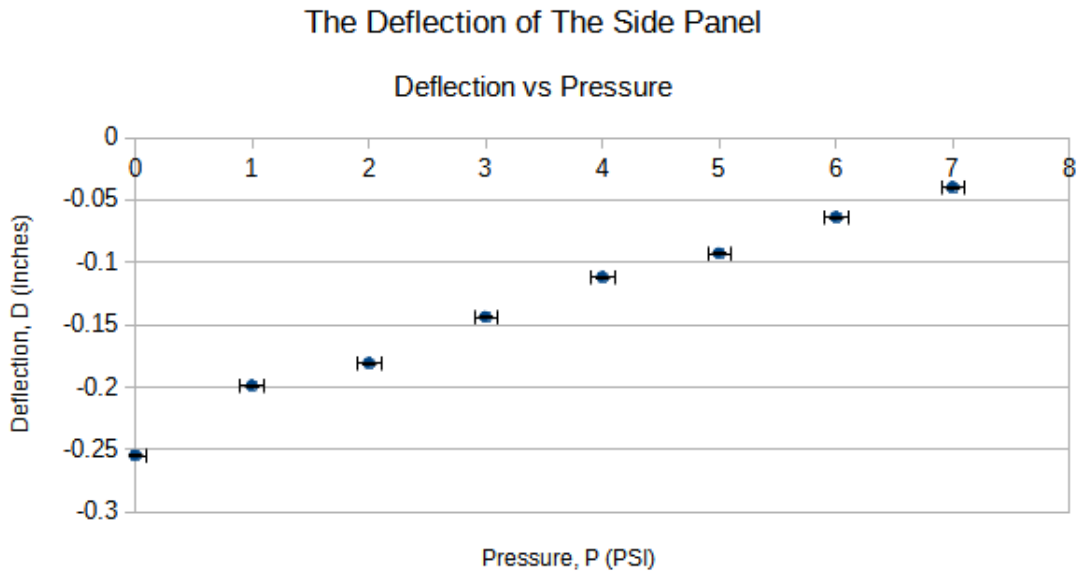
Table 4: Test 2. Deflection of the side panel in imperial units (raw data) and metric units (converted). The pressure has an error of  $\pm 0.1$  psi ( $\pm 5$  Torr), and the deflection has an error of  $\pm 0.001$  inches ( $\pm 0.003$  cm).

Figure 17: The movement of the side panel while the vessel deflates.

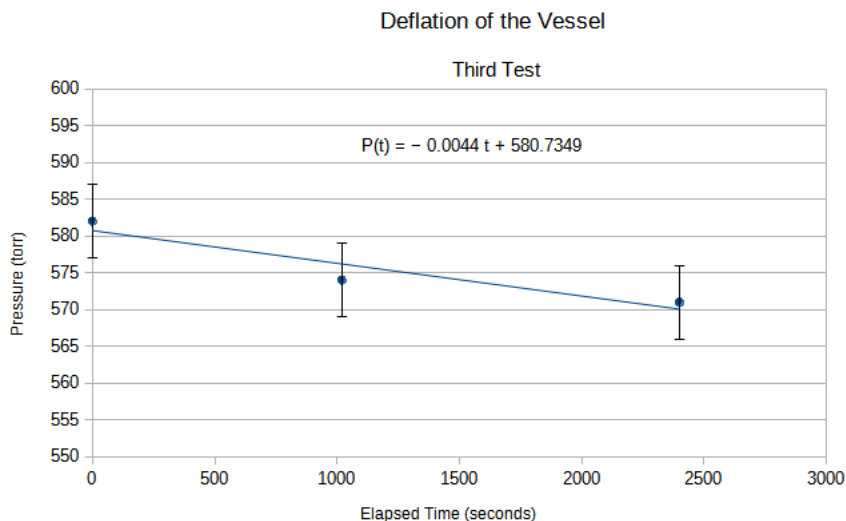
After the second test, some of the sealant was scraped off, reapplied and allowed to cure. On February 26th, the vessel was tested for leaks again with the same methods. The vessel was taken to a higher pressure this time. The results are in Tables 5, and in Fig. 18. The leak rate is  $5 \pm 1 \frac{\text{Torr}\cdot\text{L}}{\text{s}}$ .

Figure 18: Result of test 3. The leak rate of the vessel can be determined from the slope of this graph.

The leaks were found using the soapy water test:

- By the front window frame
- Between the joints of top-front plate PMT
- The corner between the top plate and the top plane PMT
- Between the front plate and the top front plate PMT

The leaks by the window frame may be caused by the window's bolt holes being torn.

After the test on February 26th, more sealant was applied to the joint of the right of the window. After the fourth vessel test, we were unsure if sealant alone can make the vessel airtight. Some sealant was reapplied to the joint to the right of the window.

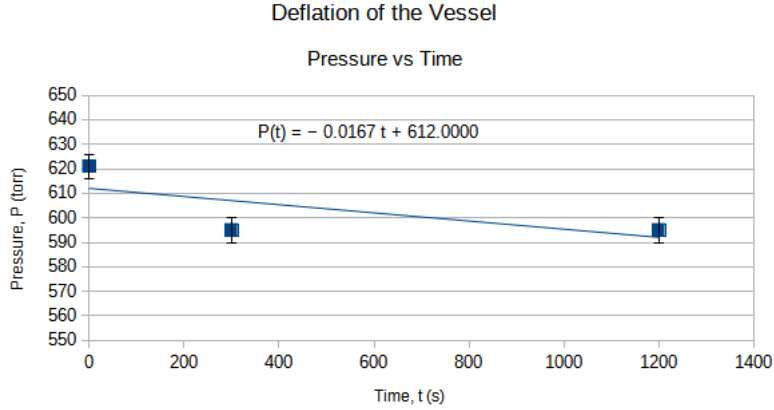
Figure 19: The deflation of the vessel before it was inflated to 15 psi (relative pressure). The change in pressure over time is  $0.017 \pm 0.002 \frac{\text{Torr}}{\text{s}}$ .

On March 1st, the vessel was tested again. It was taken to an even higher pressure than before. The results are in Table 6 and Fig. 19. The leak rate before the vessel is inflated to 15 psi is  $19 \pm 2 \frac{\text{Torr} \cdot \text{L}}{\text{s}}$ . There were more leaks discovered during this test than the third test. This may have been due to the higher pressure. On March 5th and 7th, more sealant was applied to the vessel. Extra sealant was applied to the corners of the vessel and to areas where the leaks appeared. The sealant was applied with a silicone trowel scraper with a wide radius (7mm). On the 7th, the second aluminum front window was installed on the vessel.

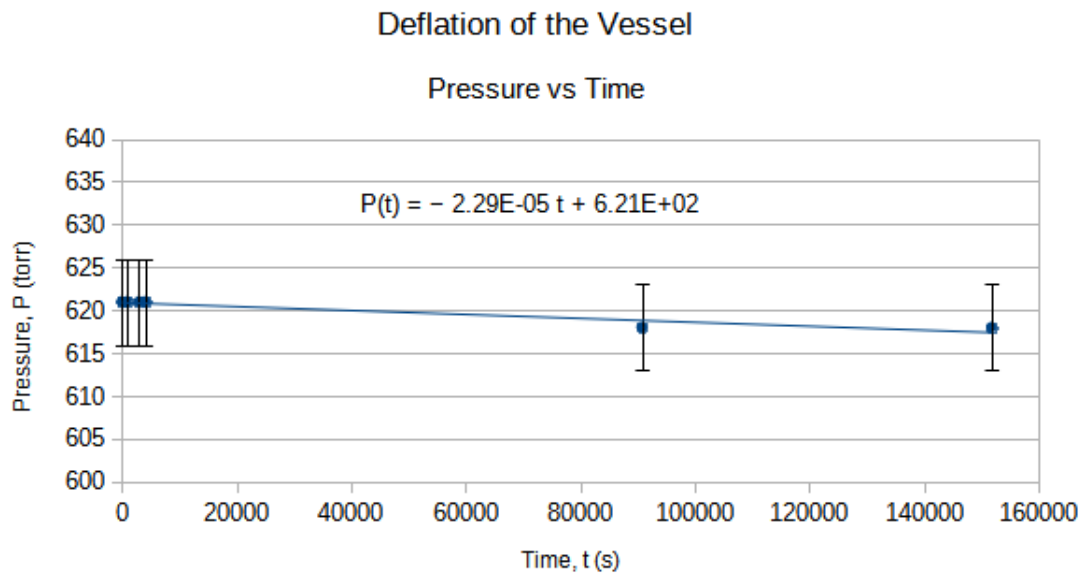
- By the long sides of the front window frame
- In the corner between the front plate, the front plane extension and the the top front plate PMT
- In-between the bottom plates
- Near the top of the side panel
- Along the seam between back plate and the back plate extension
- Near the valve and the ribs

The vessel was left for two days and a drop in pressure was observed. The results of the pressure over time are in Table 7 and Fig. 21. The leak rate is  $0.03 \pm 0.01 \frac{\text{Torr}\cdot\text{L}}{\text{s}}$ .

Figure 21: The deflation of the vessel. The change in pressure over time is  $(-2 \pm 1) \times 10^{-5} \frac{\text{Torr}}{\text{s}}$

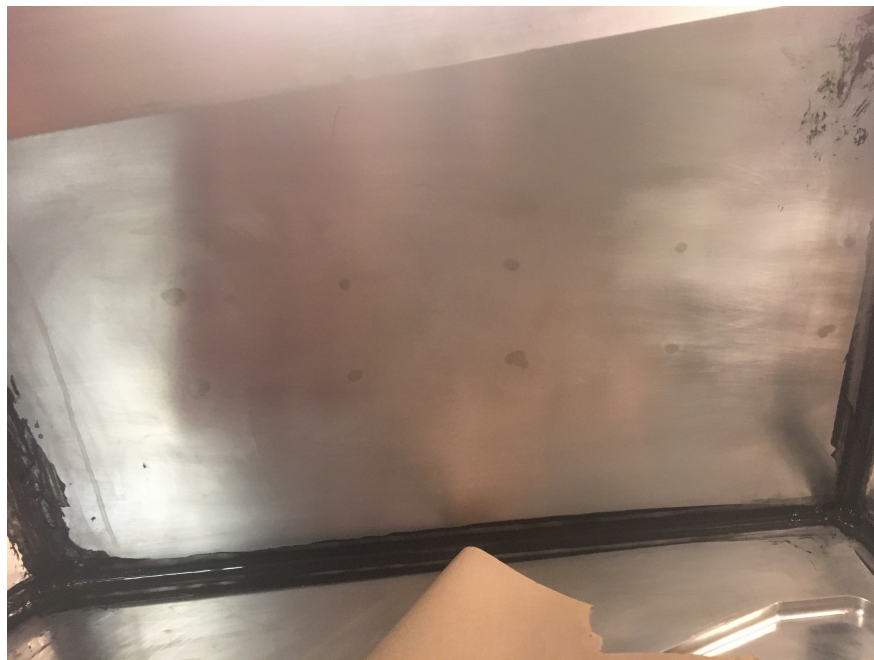
Figure 22: Discoloured blotches on the top panel.

The vessel was depressurized and the window was removed. Some discoloration was found on the inside of the top plate where the rib is bolted (see Fig. 22). This was later investigated and we found that the bolt holes in the top plate were drilled almost all the way through, due to an error in the construction drawings. Extra sealant was applied to these areas (see Fig. 23).

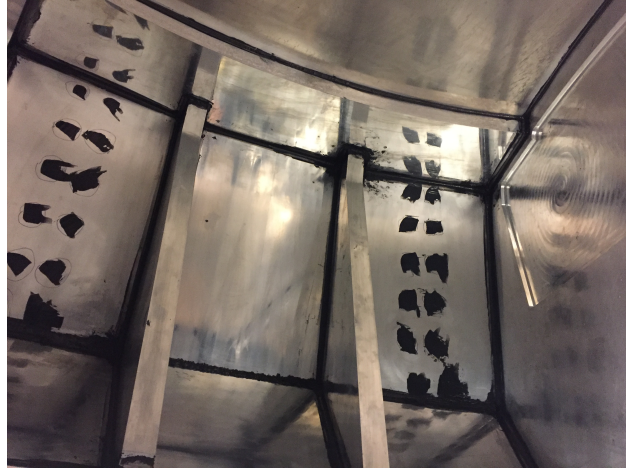
Figure 23: The stressed areas were covered with RTV sealant.

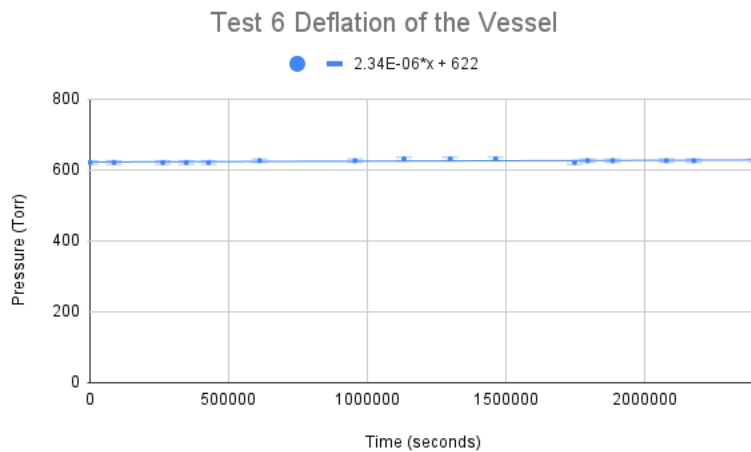
Figure 24: The deflation of the vessel over roughly a month. Assuming the gauge worked properly, the pressure over time was  $(2.3 \pm 2.8) \times 10^{-6} \frac{\text{Torr}}{\text{s}}$ . This rate is positive, but within one uncertainty of zero. The last point in Table 8, which is lower due to the sudden drop in pressure when the valve was opened, is not included in the fit.

On March 11th, the vessel was inflated with the hydrogen mixture to 12 psi (relative pressure). Using the sniffer, leaks were found in the same locations as before, but they seemed smaller. The vessel was left inflated. The next day the same leaks were found, but they were even smaller. There may be some possible issues with this test. It was found that the sniffer can be set off by the ethanol which was used to clean the vessel. It can also be set off by both cured and uncured RTV sealant. Thus, it is likely that the positive sniffer readings were simply ethanol and RTV residue.

corresponding to an upper limit of the leak rate as  $0.00056 \frac{\text{Torr}\cdot\text{L}}{\text{s}}$ . On April 8th, the valve was opened and the pressure immediately dropped to roughly 11 psi, and then continued to fall normally as the vessel depressurized. The sudden drop to 11 psi may have indicated a problem with the gauge during the long pressurization test, i.e. the needle became stuck after being in a fixed position for too long.
