SoLID Heavy Gas Cherenkov Update

Garth Huber
(on behalf of the HGC group)

HGC Prototyping Update

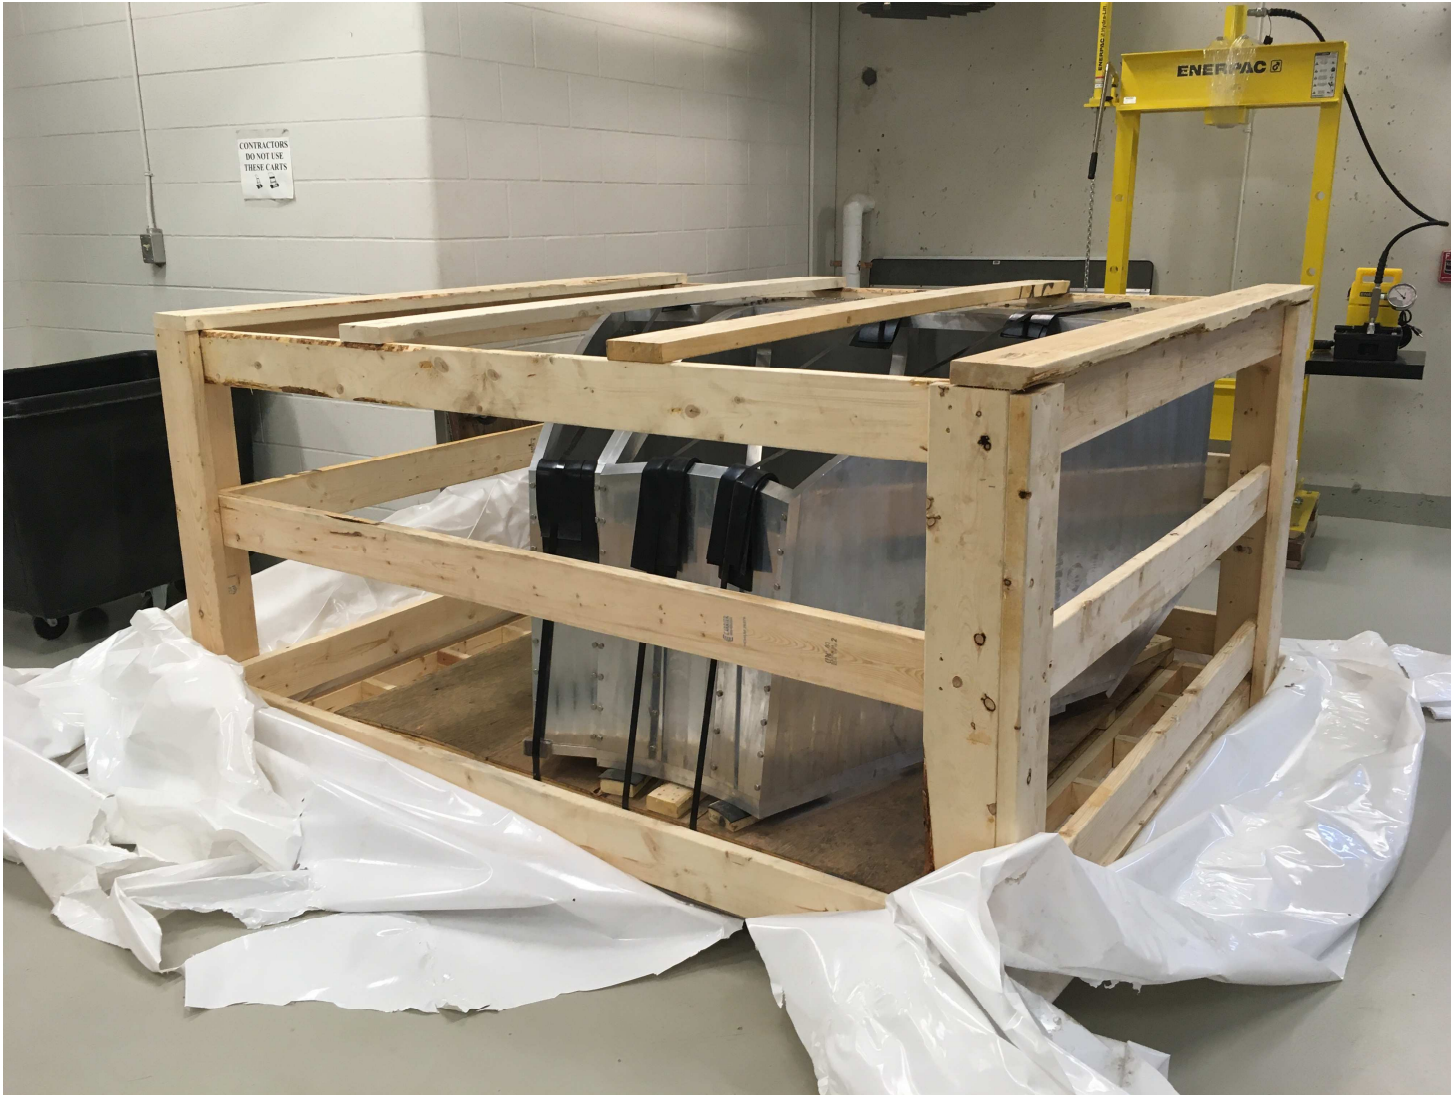
Vessel arrival from vendor March 30, 2020

Vessel arrived assembled, after vendor did dry fit to assure machining tolerances were achieved

Vessel weight:
700kg

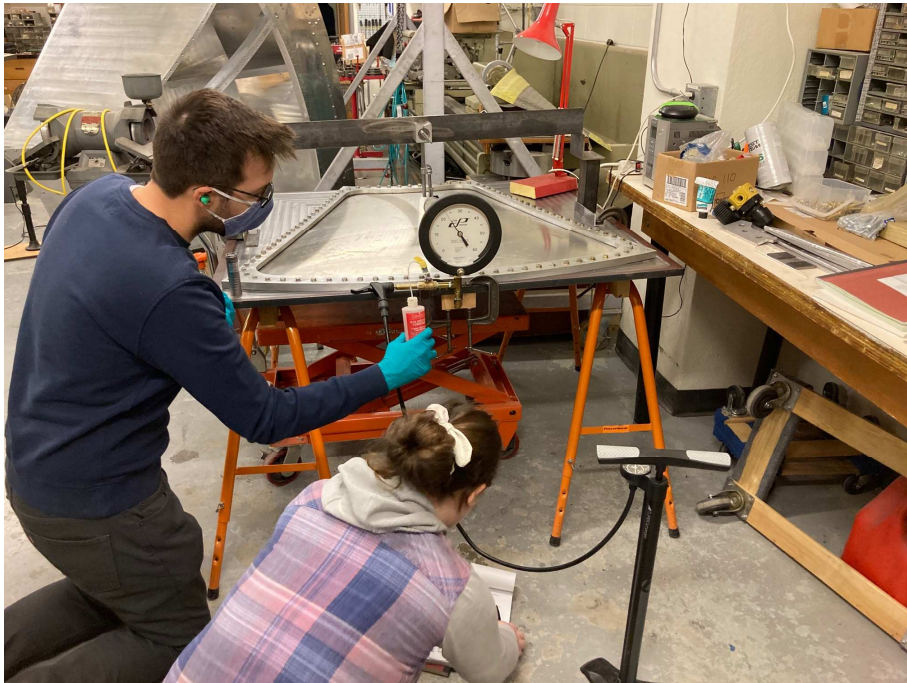
AL Entrance Window Test Results

AL window performed well, holding the pressure for long periods of time with minimal leakage at 26 psi

- $Leak_{min} = 5 \times 10^{-5}$ Torr-L/sec at test pressure (2.5 mg C_4F_8 /day)
- Cannot discount some leakage was from test setup

Maximum deflection of the window was 4.5 cm at test pressure

- Window bulge flattens with time after pressure was removed (3.5 to 1.3 cm in a few days)
- Subsequent inflations had 1cm larger bulge than initial inflation

- **The 0.04” 2024-T4 Aluminum Window met all performance specifications, tested at a higher pressure than specified by Whit Seay (2.5x operating)**
- Despite the good performance of our earlier Carbon Fiber Epoxy window (SoLID DocDB: 212), the non-repeatability of the procedure with different personnel and the failure of the new window indicates this is not a good design choice
- **Aluminum front window will be used for the HGC**
- The pressure differential range is similar (smaller) than for the SHMS HGC (where same window material is used), so further window testing should not be needed
- The new window clamp design is a significant improvement, but further refinement of design and testing will be needed with SoLID project funds

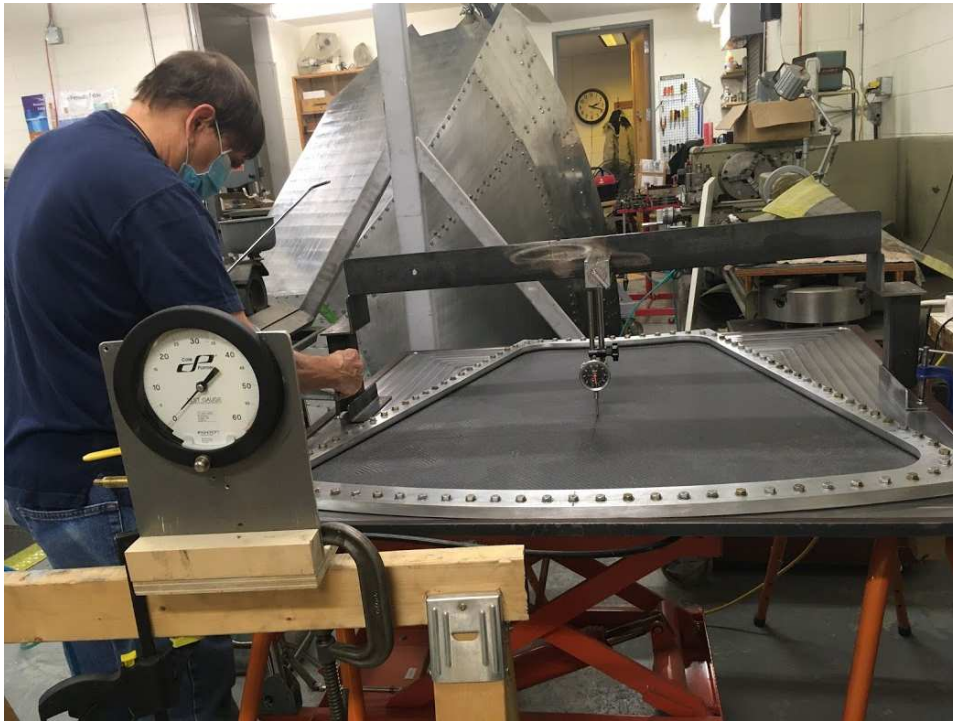
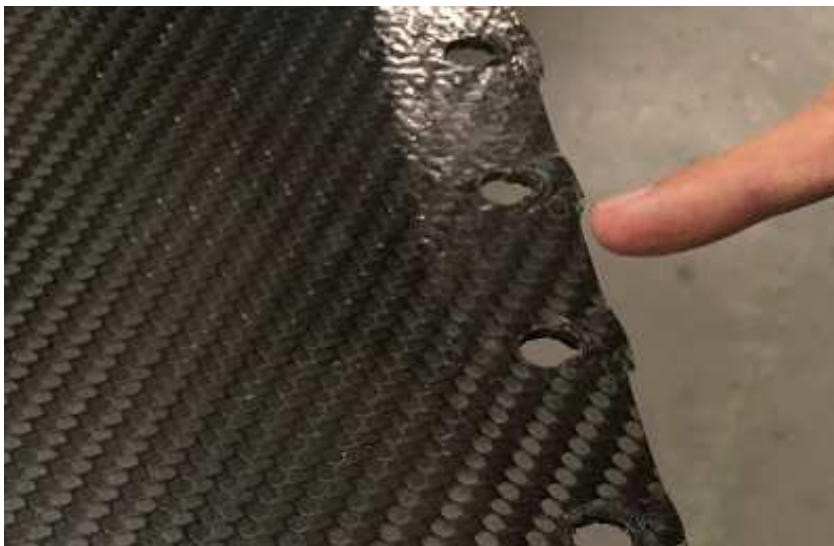
CFb Entrance Window Results

CFb window was made by a different instrument maker than earlier versions, with better 12k 2x2 twill weave vs old 3k 2x2

- First test was with Tedlar lining from CLAS-12 LTCC
- $Leak_{min} = 6.2 \times 10^{-3}$ Torr-L/sec at test pressure (0.3 g/day C_4F_8)
- Second test was same Kevlar reinforced Mylar used in earlier tests
- The CFb bolt holes ripped during second test, causing pressure failure

Maximum deflection of the window was 4.5 cm at test pressure

- Similar bulge overall to AL, except that there was less relaxation after pressure release, and less change from initial inflation

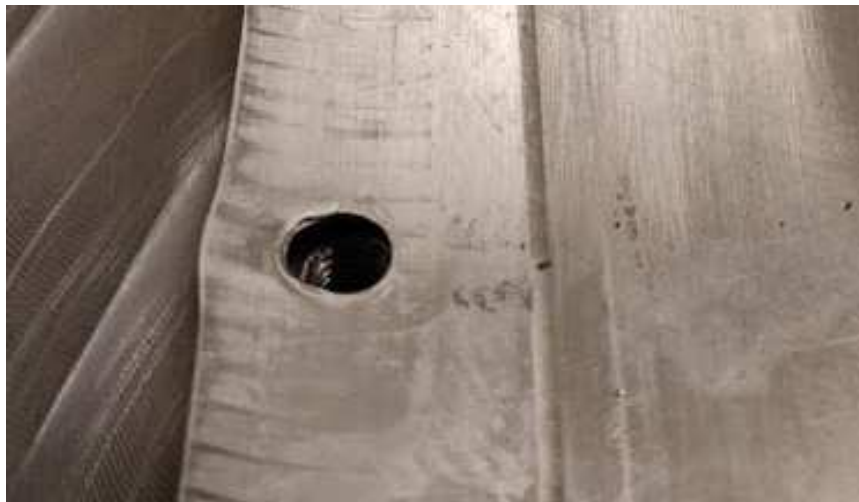
Entrance Window Clamping

Gary Swift (Duke) significantly improved the window clamp design in 2019, following our earlier experience and input from Whit Seay

- Thicker window clamp
- More space between O-ring groove and window entrance

In addition to the CFb window slippage on previous slide, the AL window also experienced some slippage when the bolts were not torqued to a sufficient level of uniformity

This indicates the window clamp design is not yet sufficient

- Most likely, decreased bolt spacing is needed (Whit Seay), as increased bolt diameter requires a wider frame
- This will need to be tested again with project funds

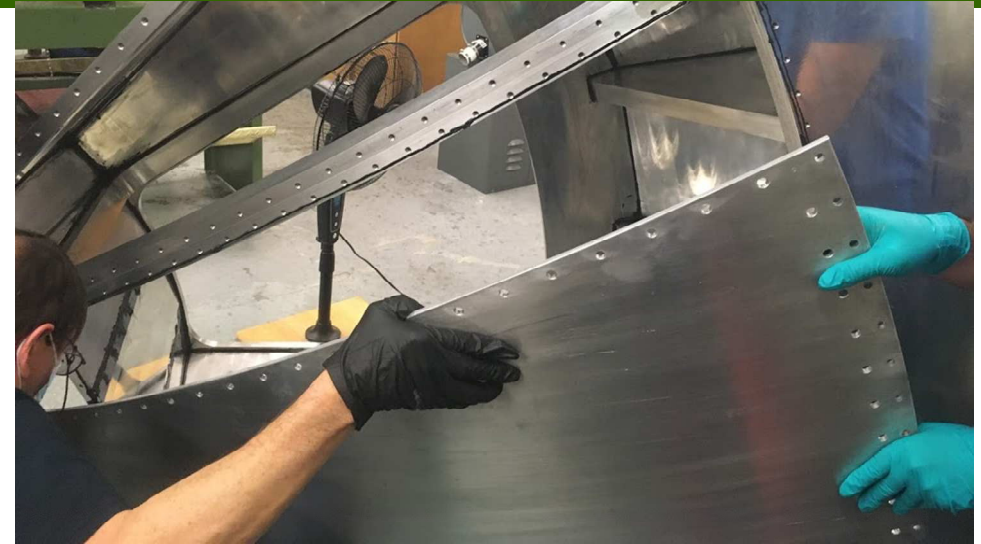
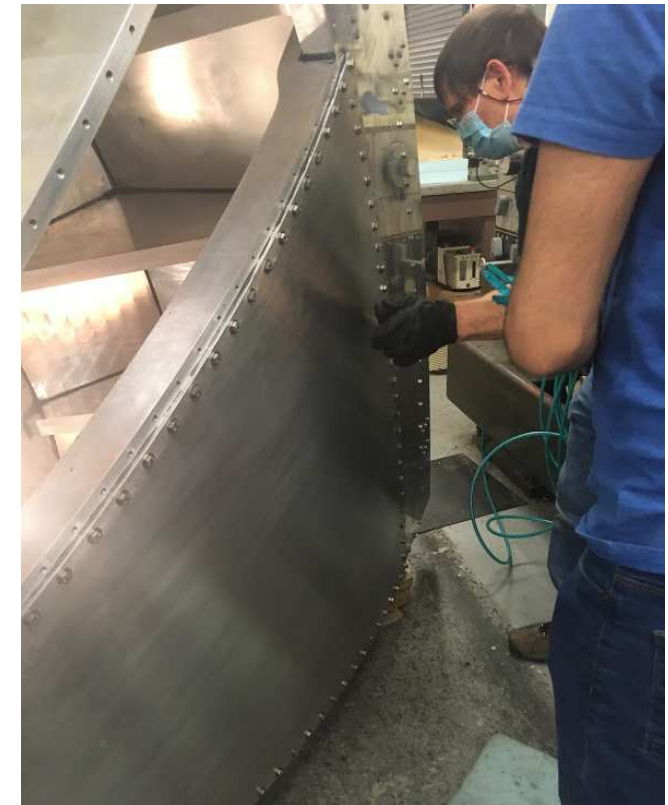
Item 2: Attach Back Window to Vessel

Shown for Reference
Mount the Flat Pattern on the Assembled Shell
Locate Mounting Holes and Bend Insitu
Trim the Bottom to Fit
Side Trimming May be Needed

- Back window thickness (1/4" AL) and shape was optimized by extensive CAD modeling (Gary Swift)
- To ensure a good fitment (needed for pressure seal), the bolt holes were pre-drilled in the window only, and were transferred by hand to the vessel, which was then drilled to match
- This was a laborious process only for the prototype. The actual detector will need a much faster method.

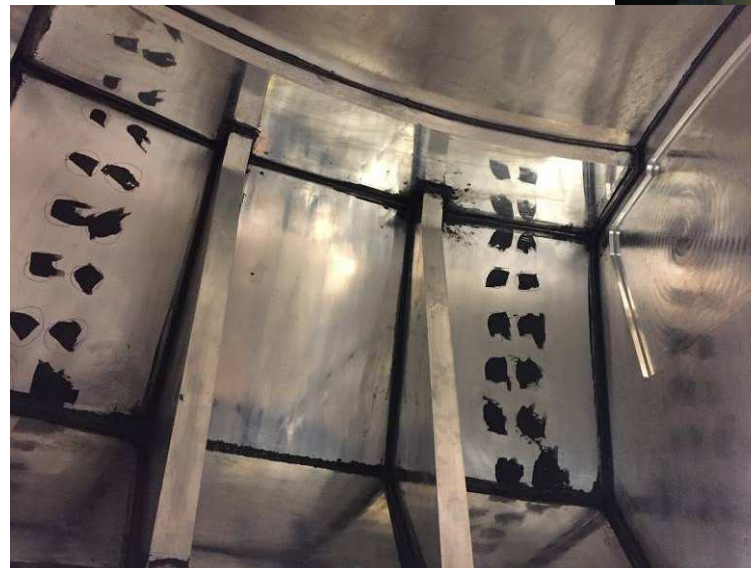
Item 3: Vessel Leak Sealing

- Vessel was cleaned with ethanol, acetone
- Vessel joints then sealed using **DOWSIL RTV 832** sealant used also on the GRINCH Cherenkov. Minimal outgassing when cured
- Vessel pressurized with air compressor and large leaks identified using soapy water
- Scratches to the walls to improve adhesion and a large RTV bead got all of the joints properly sealed
- A few design mistakes were identified as leakage through bolt holes drilled too deep (almost through)

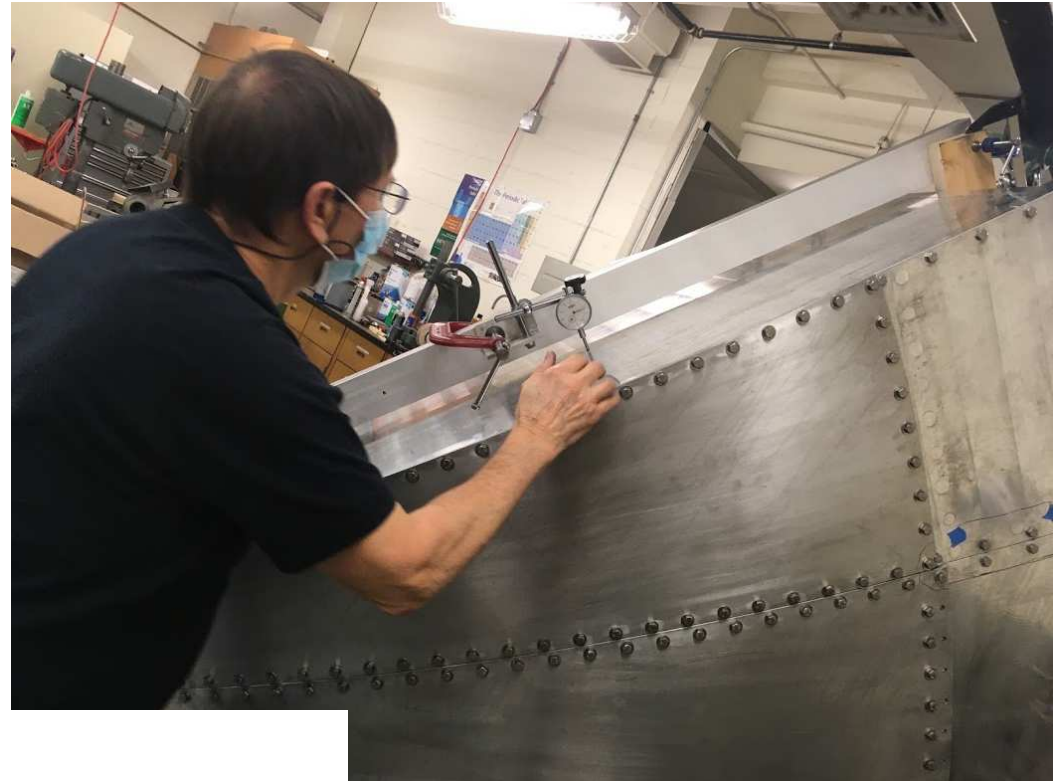
Vessel Side Panel Deflection Measurement

- Measurement of the deflection of the vessel side panel was made as it was deflated from 8 to 0 psi
- Window deflection of ~6 mm (0.25") observed
- A second test at 12 psi is planned
- **Vessel is designed for 3x safety factor, but some clearance in SoLID will be needed to accommodate HGC "swelling"**

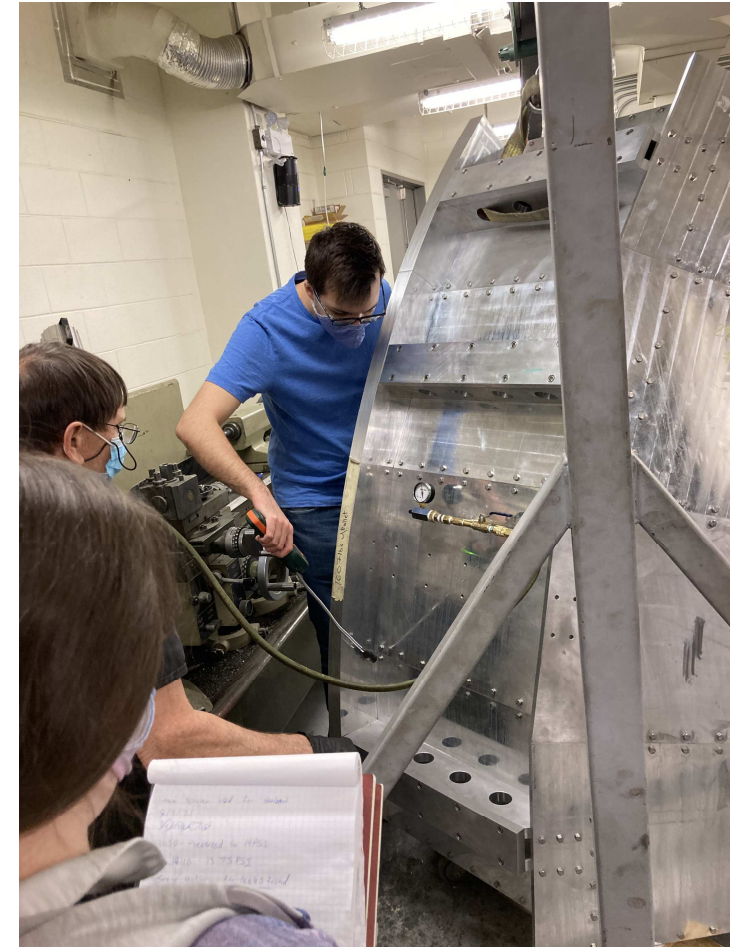
Vessel Long-Term Leak Test

- The most sensitive check for leaks was done following the procedure used on the GRINCH Cherenkov
 - The vessel was pressurized to 12 psi with a mix of 1% hydrogen/99% dry air
 - Leaks were identified with EzFlex Combustible Gas Detector (natural gas sniffer)
- **One month pressure test at 12 psi indicated negligible leakage**
- **Two month test with dry air in progress**

- **Vessel design performed very well, and was able to easily accommodate the 1.15x pressure test (12 psi) for an extended period with no safety issues**
 - Our feedback on the design has been given to Gary Swift, and we expect these small improvements to be implemented in the final detector
- After some iterations, the **DOWSIL RTV 832 sealant performed beyond our expectations**, with negligible vessel leakage indicated after 1 month
- RTV performance depends on how well the sealant is applied. For the final detector, we propose for the vendor to apply epoxy between the vessel joints as it is assembled, and RTV used to do a final seal after individual sections are delivered to JLab for HGC assembly and testing
