# SoLID HGC Prototype Vessel Leak Testing

University of Regina

June 21, 2021

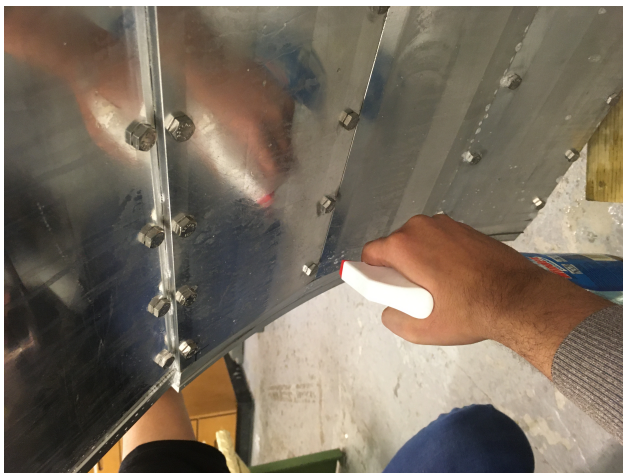
Figure 6: The soapy water test is done by spraying soapy water over the seams.

On February 8th, the front window with an O-ring was bolted to the vessel. The window's frame was accidentally placed on backwards, so it had to be taken and placed back on again. The vessel had no sealant or epoxy on it at this time. The vessel was pressurized with an air hose, but there were many leaks, enough that no differential pressure could be built up. Soapy water was sprayed onto the vessel to check for leaks (see Fig. 6). If a leak was found, it would bubble like in Fig. 7. Some of the leaks were large enough to feel by hand and to hear. They were located:

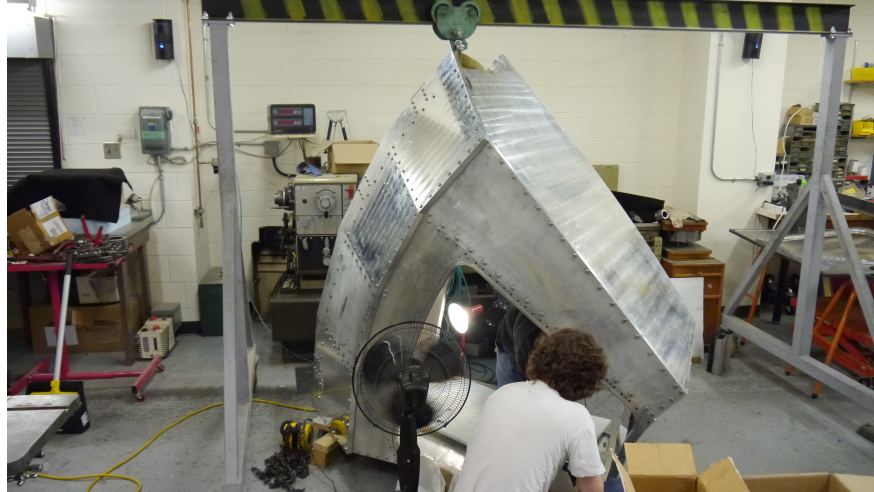
- edge of front plate towards the outer radius
- edges of side plate-left, especially where it connects to the back plate extension and the top plate
- between back Window and side plate
- between back window and rib
- a bad leak on the entire seam between the back plate and top plate
- between the top plates
- between front top and top plate

Figure 8: A fan was used to reduce fumes and a foam pad was used for comfort.

- some leaking on the bottom plates
- in the corner where the top plate, back plate and rib meets

Between February 9th–11th, the vessel was cleaned four times to prepare it for the sealant. Ethanol was used to clean most of the vessel and acetone was used to clean difficult areas. Rags were used to clean large areas, kimwipes where used to clean smaller areas and Q-tips where used to clean the seams. The first time, it was cleaned with ethanol using kimwipes. The second time, it was cleaned with ethanol using rags, kimwipes and Q-tips. The third and fourth times, it was cleaned with both ethanol and acetone separately, using rags, kimwipes and Q-tips. The cleaning was done with the vessel back panels removed, to allow for more ventilation, and a fan was used to help with air flow. Due to concerns with fumes while cleaning the vessel, breaks were given at least every hour. Foam was used for padding to protect knees. The setup can be seen in Fig. 8. The sealant was then applied on the 11th and the 12th. The setup was similar to the cleaning setup. A lamp was used to help illuminate the vessel and its heat helped the sealant to cure. Headlamps and flashlights were also used to illuminate the inside of the vessel.

About 7 tubes of RTV sealant were used. There were some challenges when applying the sealant. The sealant formed a skin rather quickly, roughly within five minutes, which made making a continuous seal difficult. If the sealant was applied too thickly, there was a tendency for air bubbles to form in the sealant. The glossy black finish made of the RTV it difficult to see imperfections in the application. On February 16th, the back panels were placed back on the vessel. RTV sealant was sandwiched between the back panels and the vessel (see Figs. 9 and 10). The panels were bolted on with 120 in-lbs of torque, as measured by a torque wrench, and the excess sealant on the inside of the vessel was smoothed down with a wet glove.

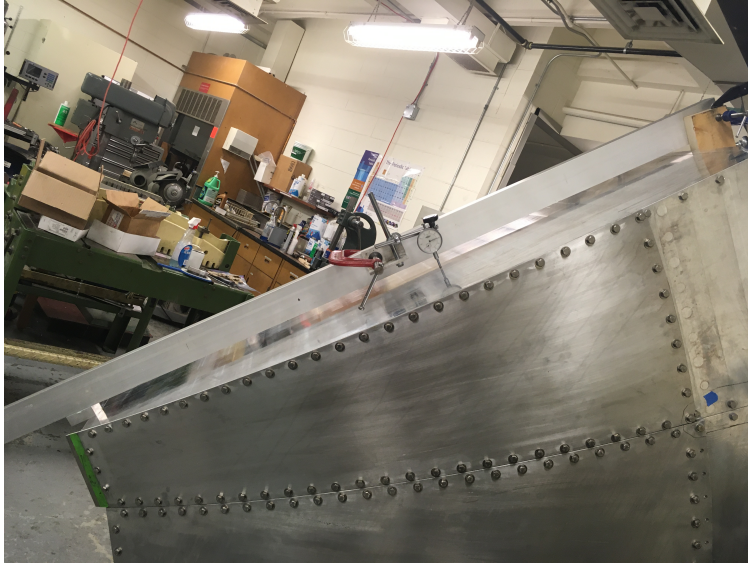
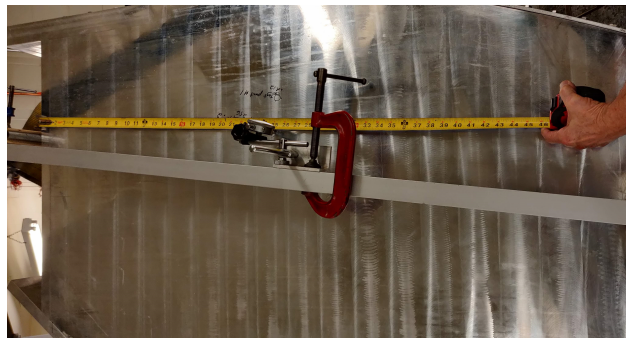
The deflection of the vessel side panel was measured. Measurements were taken by placing a dial gauge suspended by a steel beam on the panel's estimated high point (see Figs. 15 and 16). The vessel was slowly deflated and the decrease from the gauge measured the panel's deflection. The results are in Table 4 and graphed in Fig. 17.

Figure 15: How the deflection of the side panel was measured.

Figure 16: A closer look at the setup for measuring the side panel.

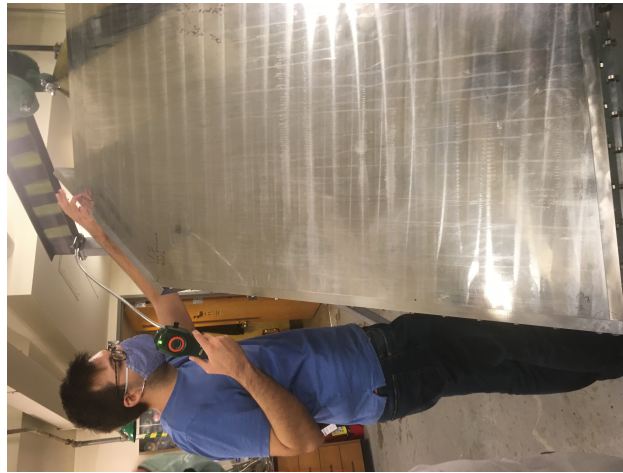
On March 8th, the vessel was first inflated with air to 14.0 psi. Soapy water was spritzed on the vessel, but no leaks were found. The vessel was then left for 2 hours and 45 minutes and the pressure dropped to 13.75 psi. The air was released from the vessel and then it was inflated with a mixture of 98.013% dry air and 1.987% hydrogen[6] to 12 psi (relative pressure). The vessel was tested for leaks using with the EZ40: EzFlex™ Combustible Gas Detector [3] natural gas sniffer (see Fig. 20). The sniffer was zeroed outside the room, so that it would tick at a slow rate. The sniffer was then brought into the room and run along the seams of the vessel. If the sniffer is ran by a leak, the tick rate will increase and we'll know that the leak is in that area. The leaks were located:

- By the long sides of the front window frame
- In the corner between the front plate, the front plane extension and the the top front plate PMT
- In-between the bottom plates
- Near the top of the side panel
- Along the seam between back plate and the back plate extension
- Near the valve and the ribs

Figure 20: The hydrogen test is done with a natural gas sniffer
